**Flood Control Project Maintenance
Levee Inspections**
LMA District Cover Sheet
Spring 2019 Levee Inspection Results

Reclamation District No. 2094 Walthall

Levee Inspection Report By Mile - Spring 2019

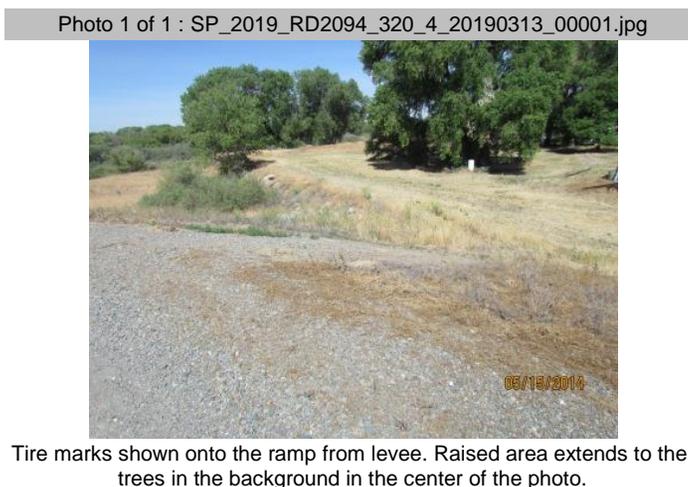
LM Start	0.10	Rating **	M	Issue No.	4
LM End	0.10	Issue Type +	En	Location *	WS
Category	Earthen Levee		GPS Latitude/Longitude		
			Start	End	
Item	Encroachments		37.771685 °	37.771685 °	
			-121.300239 °	-121.300239 °	
DWR ID	DWR_RD2094_01_s_2012_4				
Comment Code					
RA : Ramp					
Inspector Comment					
An access ramp has been built on the waterside and extends into the channel. This could potentially alter the channel capacity. This item was also noted in the USACE comments.

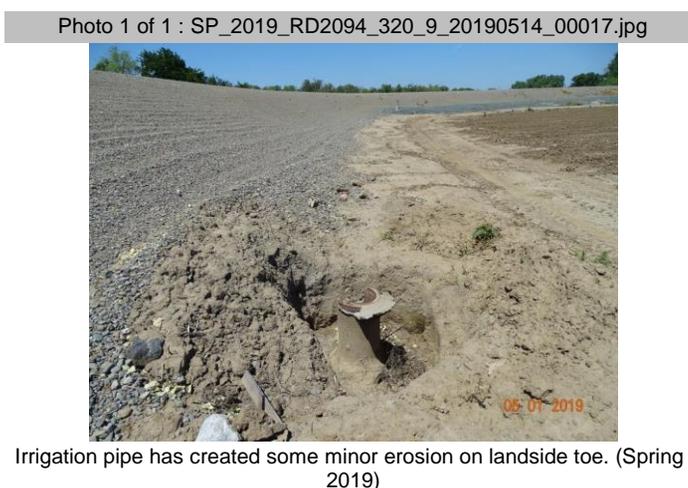
LM Start	0.28	Rating **	M	Issue No.	9
LM End	0.28	Issue Type +	En	Location *	LS
Category	Earthen Levee		GPS Latitude/Longitude		
			Start	End	
Item	Encroachments		37.769281 °	37.769281 °	
			-121.300832 °	-121.300832 °	
DWR ID	DWR_RD2094_01_s_2019_9				
Comment Code					
PI : Pipe					
Inspector Comment					
An irrigation pipe on the landside toe has created some erosion and needs to be backfilled and compacted before the flood season.

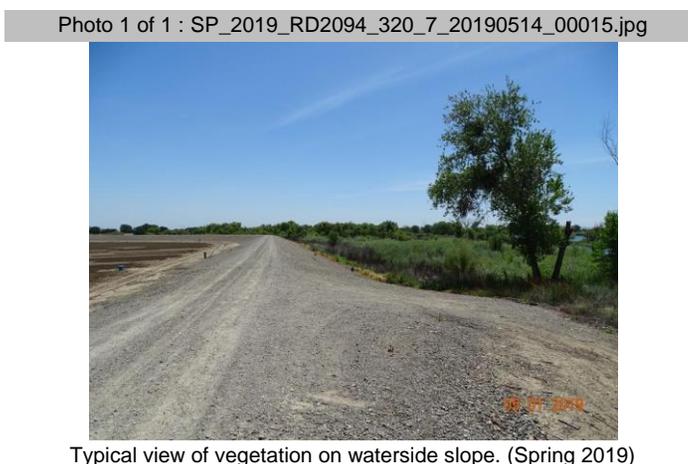
LM Start	0.28	Rating **	A	Issue No.	7
LM End	2.78	Issue Type +	Ma	Location *	WS
Category	Earthen Levee		GPS Latitude/Longitude		
			Start	End	
Item	Vegetation		37.769280 °	37.749548 °	
			-121.300827 °	-121.288901 °	
DWR ID	DWR_RD2094_01_s_2019_7				
Comment Code					
V1 : Control annual grass and weeds on the levee slopes and easements.					
Inspector Comment					
Annual vegetation is well maintained.

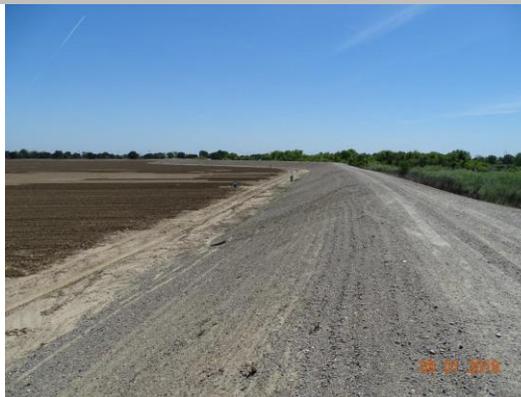
Photo 1 of 1 : SP_2019_RD2094_320_6_20190514_00016.jpg

LM Start	0.28	Rating **	A	Issue No.	6
LM End	2.78	Issue Type +	Ma	Location *	LS
Category	Earthen Levee			GPS Latitude/Longitude	
				Start	End
Item	Vegetation			37.769278 °	37.749548 °
				-121.300824 °	-121.288901 °
DWR ID	DWR_RD2094_01_s_2019_6				
Comment Code					
V1 : Control annual grass and weeds on the levee slopes and easements.					
Inspector Comment					
Annual vegetation is well maintained.

Typical view of vegetation on landside slope. (Spring 2019)

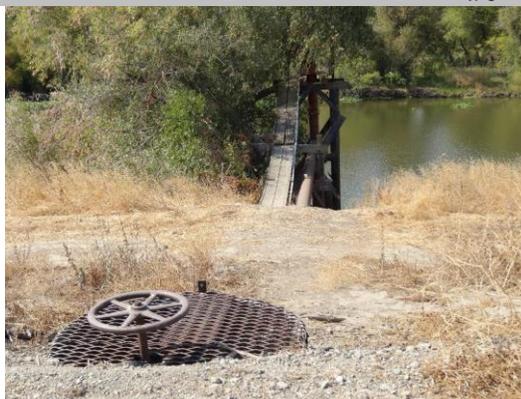
Photo 1 of 3 : UCIP_SP_2019_21464_36405.jpg

Comment Code					
Inspector Comment					
FS_ID:21464 DS_ID:23086 EP_NO: N/A Repair Type: Non-Urgent Crossing Status: Found UCIP Comments: - walkway in poor condition and needs repair.- electric conduit on waterside. FIELD_STRUCT_DESC: 14-inch concrete encased steel irrigation discharge pipe and galvanized iron (GI) electrical conduit through the levee, 10 feet below the crown. Two concrete cutoff walls. Pump mounted on a pile structure in the stream. Slide gate in a 54-inch corrugated metal pipe (CMP) riser on the waterside (WS) shoulder. Concrete distribution box and service pole at the landside (LS) toe. Installed by USACE in 1962. [Additional Reference(s): DWR Levee Log, 2005. USACE San Joaquin O&M Manual 3, December 1968, (HLM 0.66)]. FS Date: 9/10/2013

WS view: gate valve in CMP riser (bottom) and pipe & pump (top) on piling structure in the channel.

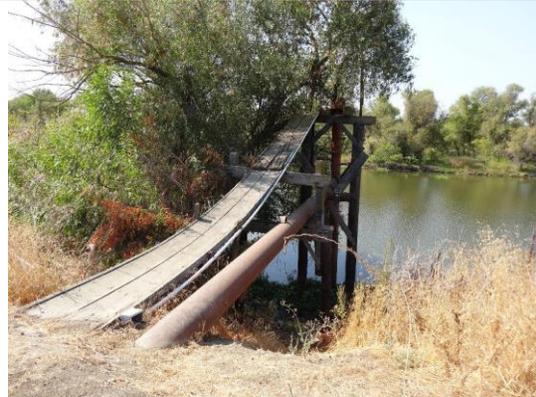
Photo 2 of 3 : UCIP_SP_2019_21464_36404.jpg

WS view: pump on piling structure in the channel. Pipe (right- bottom) and conduit (bottom- left).

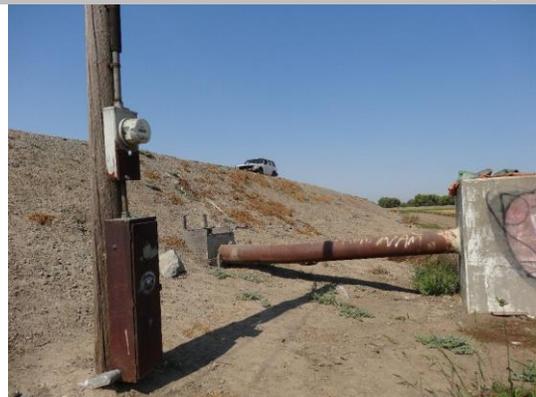
Photo 3 of 3 : UCIP_SP_2019_21464_36403.jpg

LS view: exposed pipe, service pole, and concrete distribution box on levee toe.

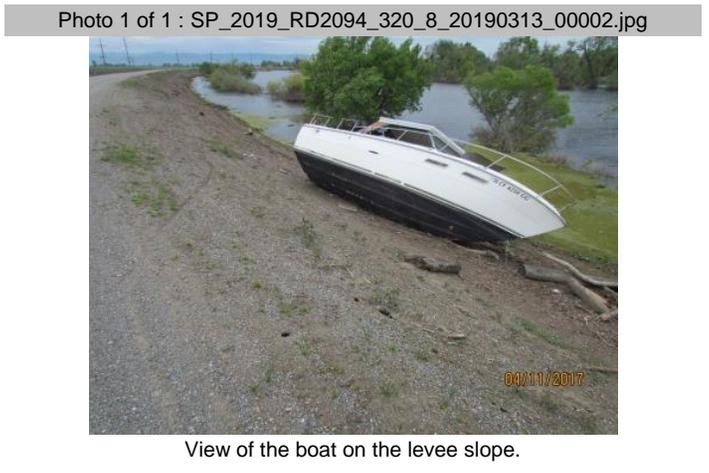
LM Start	0.91	Rating **	M	Issue No.	8
LM End	0.91	Issue Type +	En	Location *	WS
Category	Earthen Levee		GPS Latitude/Longitude		
			Start	End	
Item	Encroachments		37.764169 °	37.764169 °	
			-121.293562 °	-121.293562 °	
DWR ID	DWR_RD2094_01_s_2017_8				
Comment Code					
AV : Abandoned vehicles					
Inspector Comment					
Remove boat from the levee slope.

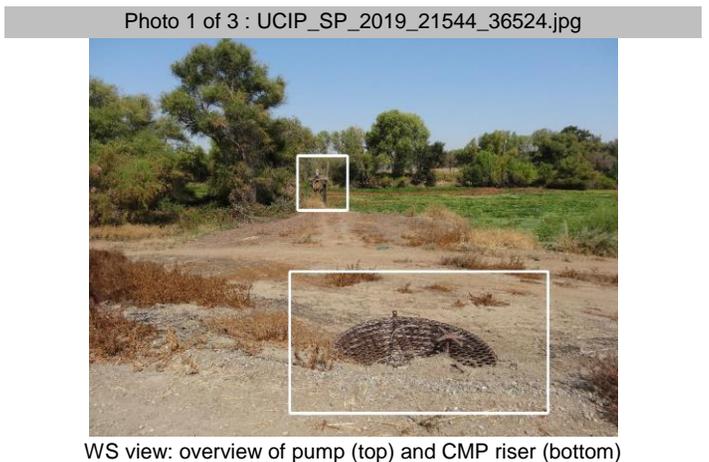
Comment Code					
Inspector Comment					
FS_ID:21544 DS_ID:23087 EP_NO: N/A Repair Type: Non-Urgent Crossing Status: Found UCIP Comments: - working as drainage system during field visit. Pump was not running.- electric conduit on WS- open pipe end in CMP riser. CMP needs cleaning. FIELD_STRUCT_DESC: 20-inch concrete encased steel irrigation discharge pipe through the levee, 10 feet below the crown. Two concrete cutoff walls. Pump mounted on a pile structure in the stream. Slide gate in a 54-inch corrugated metal pipe (CMP) riser on the waterside (WS) shoulder. Concrete distribution box and service pole at the landside (LS) toe. [Additional Reference(s): DWR Levee Log, 2005. USACE San Joaquin O&M Manual 3, December 1968, (HLM 1.27)]. FS Date: 9/10/2013

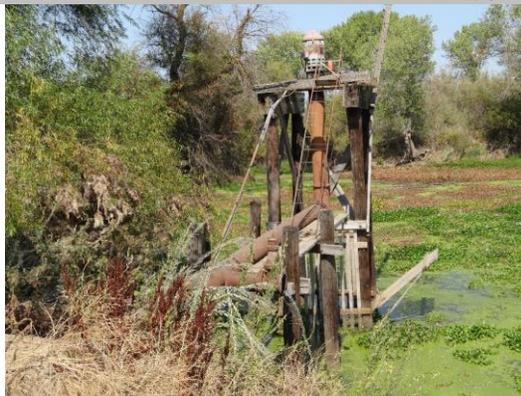
Photo 2 of 3 : UCIP_SP_2019_21544_36523.jpg

WS view: pipe and pump on piling structure in the channel. Walkway in poor condition.

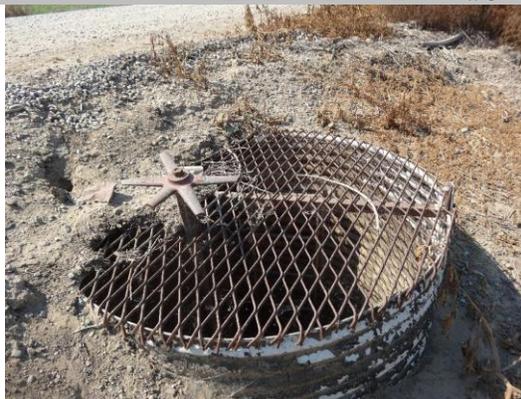
Photo 3 of 3 : UCIP_SP_2019_21544_36522.jpg

WS view: damaged gate valve handle in CMP riser on levee shoulder.

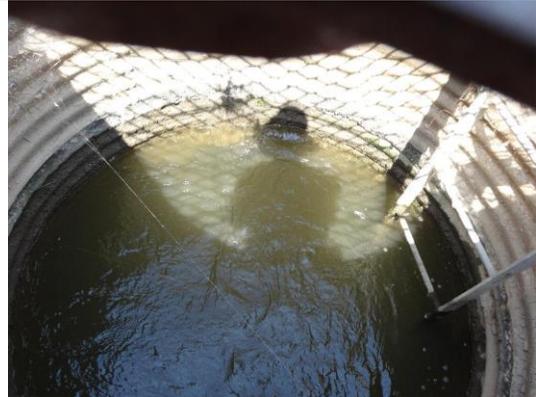
Photo 3 of 3 : UCIP_SP_2019_41726_36500.jpg

Comment Code					
Inspector Comment					
FS_ID:41726 DS_ID:23088 EP_NO: N/A Repair Type: Non-Urgent Crossing Status: Found UCIP Comments: - dense vegetation on WS.- working during field survey.- slide gate not found on WS. FIELD_STRUCT_DESC: 20-inch concrete encased steel irrigation discharge pipe through the levee, 6 feet below the crown. Two concrete cutoff walls. Slant pump mounted on a frame structure on the stream bank. Slide gate in a 54-inch corrugated metal pipe (CMP) riser on the waterside (WS) shoulder. Concrete distribution box and service pole at the landside (LS) toe. [Additional Reference(s): DWR Levee Log, 2005. USACE San Joaquin O&M Manual 3, December 1968, (HLM 2.30)]. FS Date: 9/10/2013

WS view: inside view of CMP riser on levee shoulder. No slide gate found.

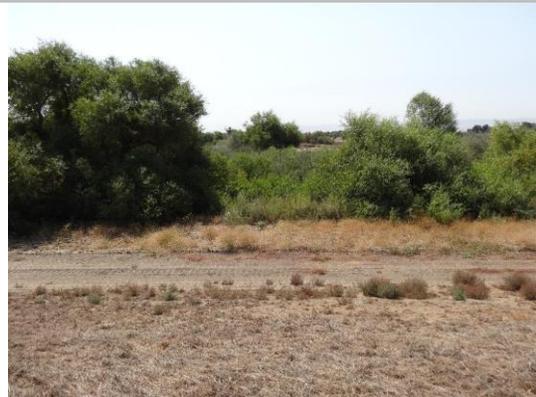
Photo 1 of 3 : UCIP_SP_2019_21545_36529.jpg

LM Start	2.45	Rating **	M	Issue No.	16
LM End	2.45	Issue Type +	En	Location *	
Category	Supplemental		GPS Latitude/Longitude		
			Start	End	
Item	DWR UCIP Field Study		37.752308 °	37.752308 °	
			-121.293191 °	-121.293191 °	
DWR ID	23089				
Comment Code					
Inspector Comment					
FS_ID:21545 DS_ID:23089 EP_NO: N/A Repair Type: Non-Urgent Crossing Status: Found UCIP Comments: - no pipes found on either side of the levee.- concrete distribution box on LS. Soil erosion around distribution box. FIELD_STRUCT_DESC: Rectangular concrete distribution box on the landward toe FS Date: 9/10/2013

WS view: no pipe found on waterside.

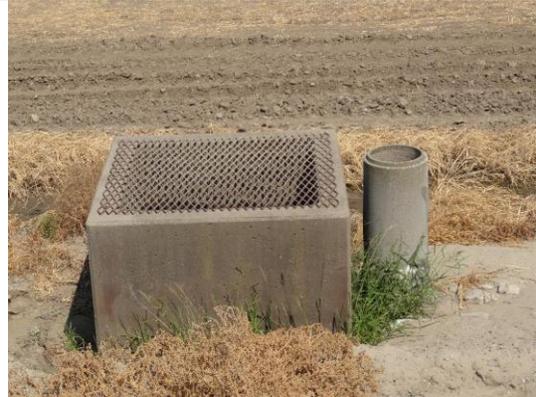
Photo 2 of 3 : UCIP_SP_2019_21545_36528.jpg

LM Start	2.45	Rating **	M	Issue No.	16 (cont)
LM End	2.45	Issue Type +	En	Location *	
Category	Supplemental			GPS Latitude/Longitude	
				Start	End
Item	DWR UCIP Field Study			37.752308°	37.752308°
				-121.293191°	-121.293191°
DWR ID	23089				
Comment Code					
Inspector Comment					
FS_ID:21545 DS_ID:23089 EP_NO: N/A Repair Type: Non-Urgent Crossing Status: Found UCIP Comments: - no pipes found on either side of the levee.- concrete distribution box on LS. Soil erosion around distrinition box. FIELD_STRUCT_DESC: Rectangular concrete distribution box on the landward toe FS Date: 9/10/2013

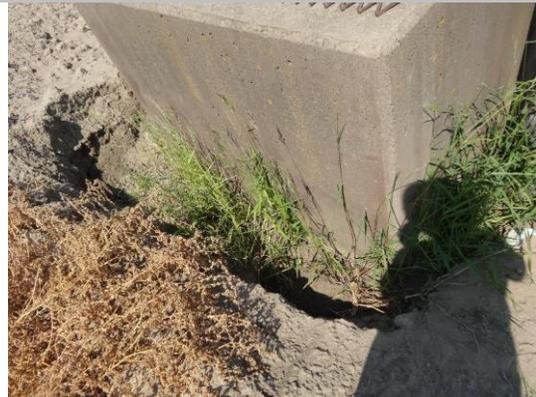
Photo 3 of 3 : UCIP_SP_2019_21545_36527.jpg

LS view: erosion around a concrete standpipe on the landside toe.

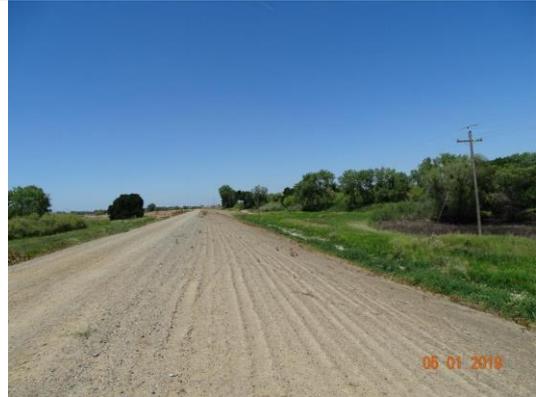
Photo 1 of 1 : SP_2019_RD2094_321_1_20190514_00001.jpg

LM Start	0.06	Rating **	A	Issue No.	1
LM End	0.45	Issue Type +	Ma	Location *	WS
Category	Earthen Levee		GPS Latitude/Longitude		
			Start	End	
Item	Vegetation		37.759668°	37.760587°	
			-121.300474°	-121.307271°	
DWR ID	DWR_RD2094_02_s_2019_1				
Comment Code					
V1 : Control annual grass and weeds on the levee slopes and easements.					
Inspector Comment					
Annual vegetation is well maintained.

Typical view of vegetation on waterside slope. (Spring 2019)
